AIRSUB: Autonomous Robot For Dam Inspection

P. Ridaó (1), M. Carreras (2), J. Batlle (3)

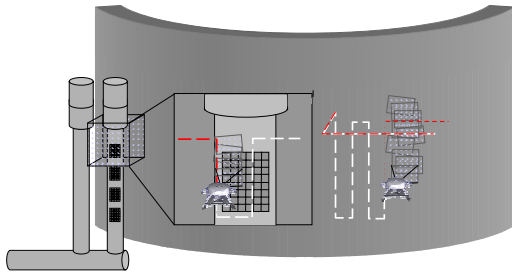
Fig. 1 Sketch of the inspection task of the concrete and the grille of the inlet.

Civil engineers of the hydroelectric companies, carry out periodic visual inspections of the state of the concrete. Until now this is commonly achieved through a careful visualization of a video recorded by a professional diver. Our approach to this problem will consist on the use of an AUV which will follow a pre-programmed path in face of the wall while snapping images (Fig.1). For the localization, two systems will be studied:

1. a **dead reckoning** system based on the integration of velocities measured with respect the wall using a **DVL** in ground tracking mode (ground is now the wall).
2. An **USBL** system connected to a DGPS in order to be able to **geo-reference** the AUV and hence, the imagery taken by the robot.

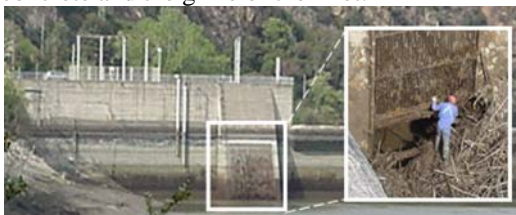
Fig. 2 Vegetal residuals obstructing the water inlet of Pasteral Dam in Girona.

With the time, the grille of the water inlet gets obstructed with the vegetal residuals (Fig. 2) normally transported by the rivers. The result is a loss of power during the generation process. Hence, this grille should be regularly inspected in order to schedule cleaning campaigns commonly carried out by professional divers. From the inspection point of view, this is the same problem faced in the previous section and therefore, we plan to address the task in the terms explained before.

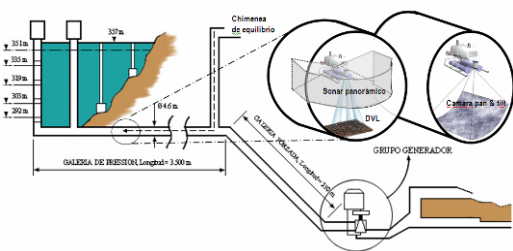
Fig. 3 Sketch of the inspection task of the penstock gallery.

With time, small collapse problems can appear in the penstock gallery and it is necessary to assess their risk to ensure the safety of the installation. The penstock gallery is a big pipe (~ 4 m diameter, up to 4 Km long) which connects the water inlet with the power generator (Fig.3).

For the inspection of this gallery, we plan to launch an AUV, from the equilibrium chimney, which will navigate through the pipe while taking images of the state of the gallery. The plan is to navigate based on DVL and a gyrocompass measurements, using an Imaging sonar to keep the robot in the centre of the pipe during the operation.
